## Accident: Emirates A345 at Melbourne on Mar 20th 2009, tail strike and overrun on takeoff

An Emirates Airlines Airbus A340-500, registration A6-ERG performing flight EK-407 from Melbourne, VI (Australia) to Dubai (United Arab Emirates) with 257 passengers and 18 crew, experienced a tail strike on takeoff from Melbourne's runway 16 (length 3657 meters/12000 feet) at around 22:30 local (11:30Z), hit the

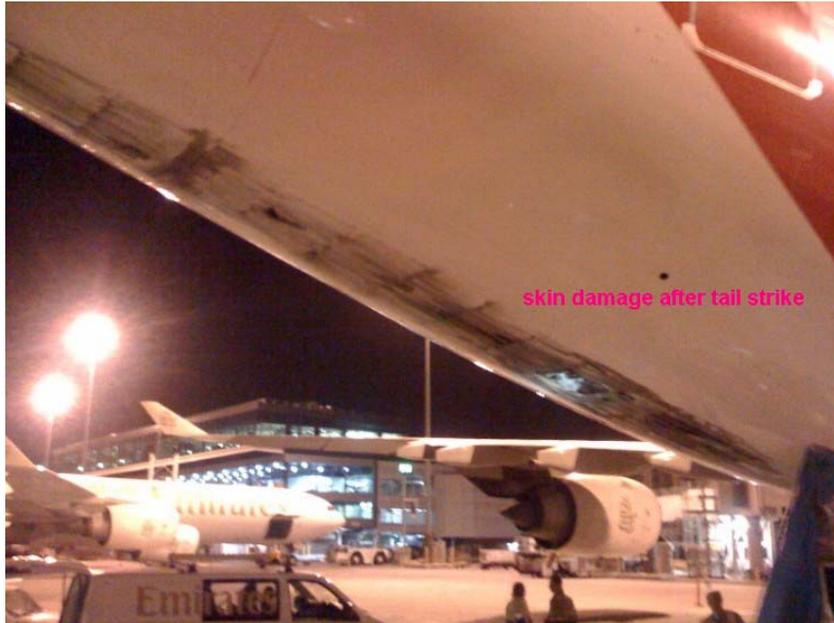
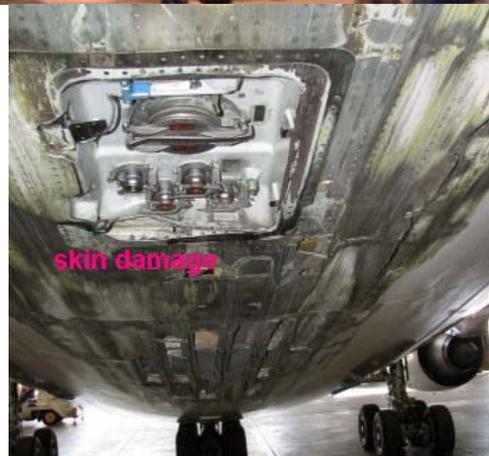
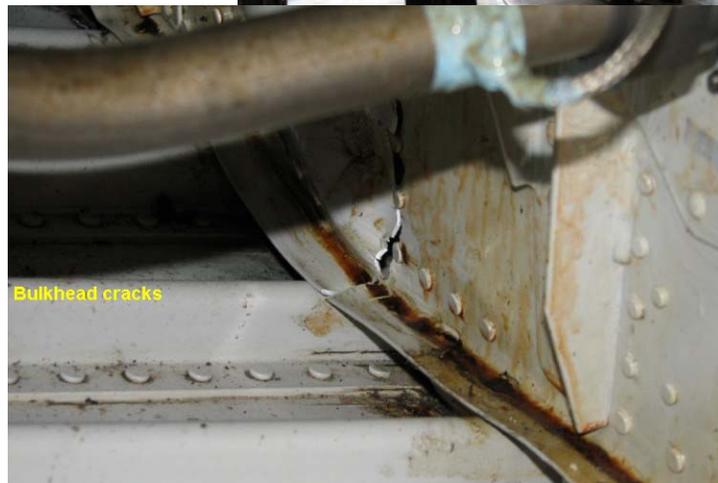
Severe abrasions occurred to the tail skin and several access panels were ripped off during the tailstrike, the landing reportedly caused additional damage to the gear.

In daylight it was established, that the airplane was still on the ground when it passed the runway end during takeoff, according gear tracks were found in the soft ground past the runway end.

The aircraft received abrasions at the rear lower fuselage skin, a dislodged service panel, several deformations of fuselage frames and stringers, several of which contained cracks, and cracks and deformation of the rear pressure bulkhead. A contact mark was in the inner rear tyre of the left main gear.

Damage also occurred to fixed approach lights, instrument landing system monitoring antennas and the localizer antenna.

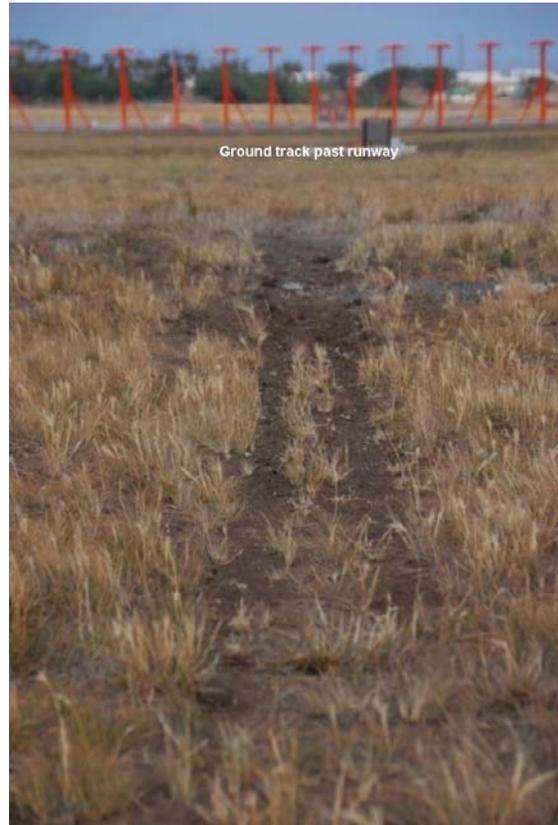
The first officer was pilot flying for the leg, the captain was pilot monitoring for the reduced power takeoff on runway 16. The airplane reached V1 (143 knots) 1118 meters before the runway end. The captain called rotate, the first officer attempted to rotate the aircraft when the aircraft was 964 meters before the runway end, which however did not respond. The captain called again "rotate", the first officer applied more backpressure resulting in the nose lifting (886 meters before runway end) and the tail struck the runway surface 229 meters before the runway end, but the airplane did not begin to climb. The captain applied maximum thrust by moving the throttles into the TOGA detent at the runway end and the airplane

eventually commenced a climb with the main gear uncompressing 115 meters past the runway end. "During the take-off, the aircraft's tail contacted the ground beyond the end of the runway and a number of airport landing aids came into contact with the aircraft." The airplane subsequently impacted approach lighting, the instrument landing system monitoring antenna and struck the localizer antenna with its left main gear disabling the localizer function. A positive rate of climb was established 292 meters past the runway end.
