## Accident: Emirates A345 at Melbourne on Mar 20th 2009, tail strike and overrun on takeoff

An Emirates Airlines Airbus A340-500, registration A6-ERG performing flight EK-407 from Melbourne, VI (Australia) to Dubai (United Arab Emirates) with 257 passengers and 18 crew, experienced a tail strike on takeoff from Melbourne's runway 16 (length 3657 meters/12000 feet) at around 22:30 local (11:30Z), hit the

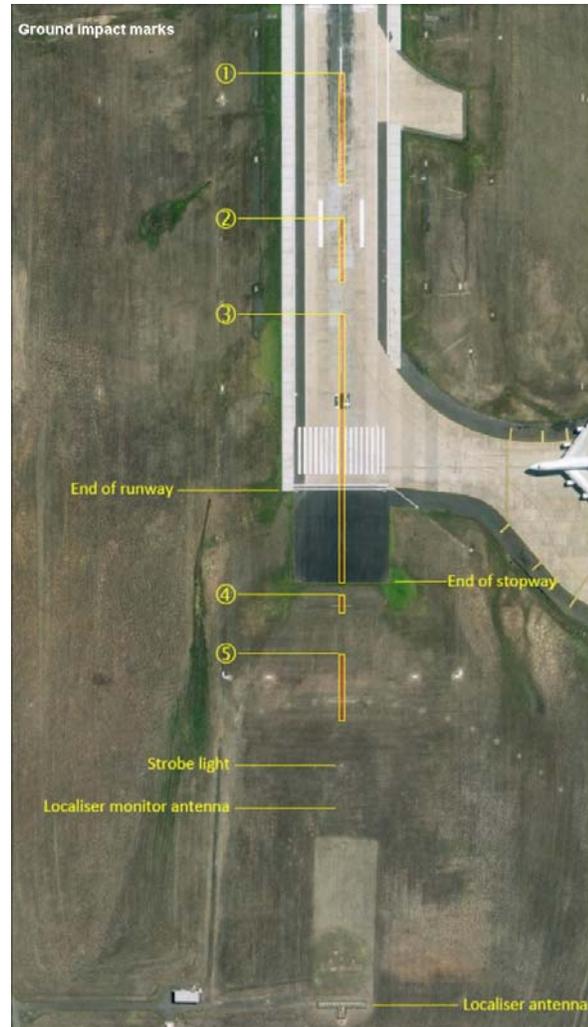
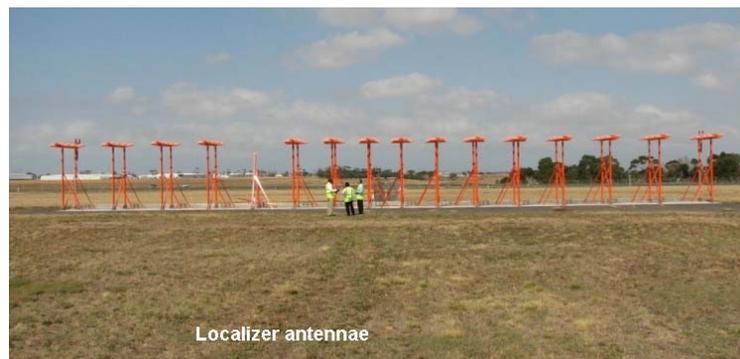
The aircraft received abrasions at the rear lower fuselage skin, a dislodged service panel, several deformations of fuselage frames and stringers, several of which contained cracks, and cracks and deformation of the rear pressure bulkhead. A contact mark was in the inner rear tyre of the left main gear.

Damage also occurred to fixed approach lights, instrument landing system monitoring antennas and the localizer antenna.

According to a report by "The Herald Sun" (Australia) the airplane was just about 70cm above ground, when it wiped out runway approach lights about 170 meters from the end of the runway. After taking the localizer antenna out the airplane barely made it over the airport fence, 2.44 meters high.
